## 2.0 ANALYSIS

## **2.5 Analysis of the chronological main events**

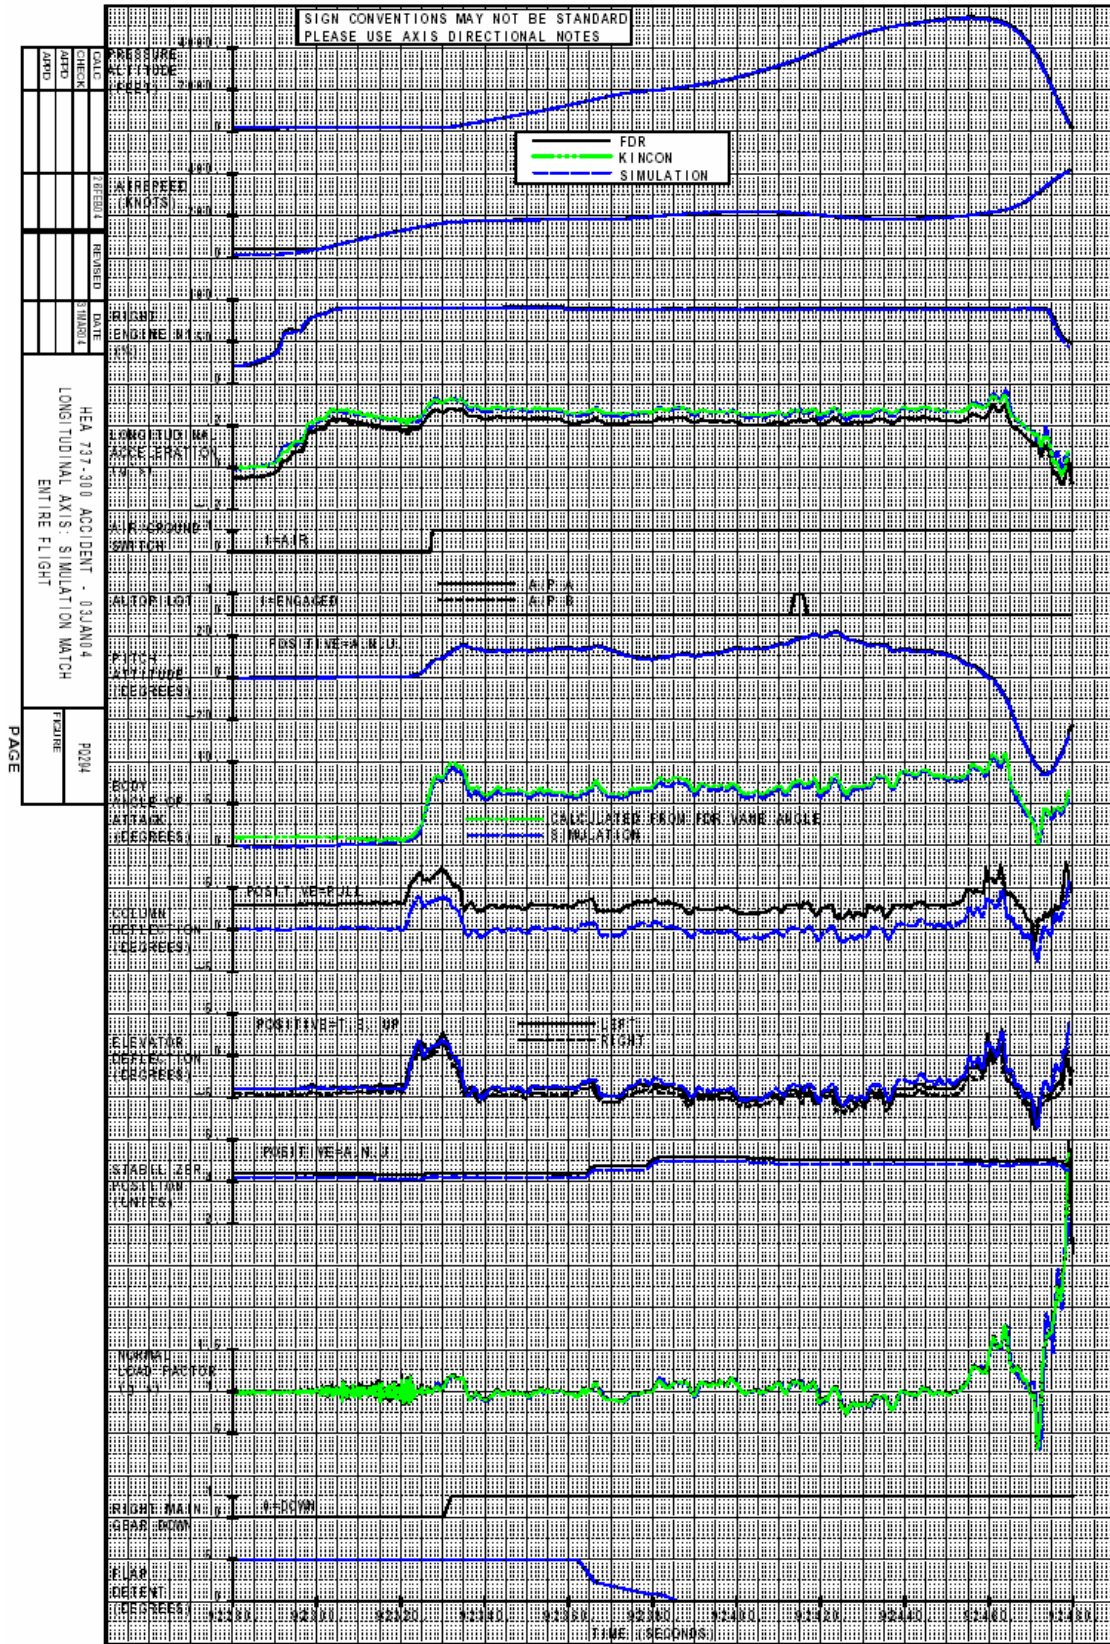
Figure 1.16.2-1 – FDR and Simulation Match Data – Longitudinal Axis

An examination of the baseline simulation revealed that the path of the accident airplane is consistent with the recorded motion of the control surfaces. Specifically, the extreme bank attitude that occurs towards the end of the flight is consistent with recorded motion of the ailerons.

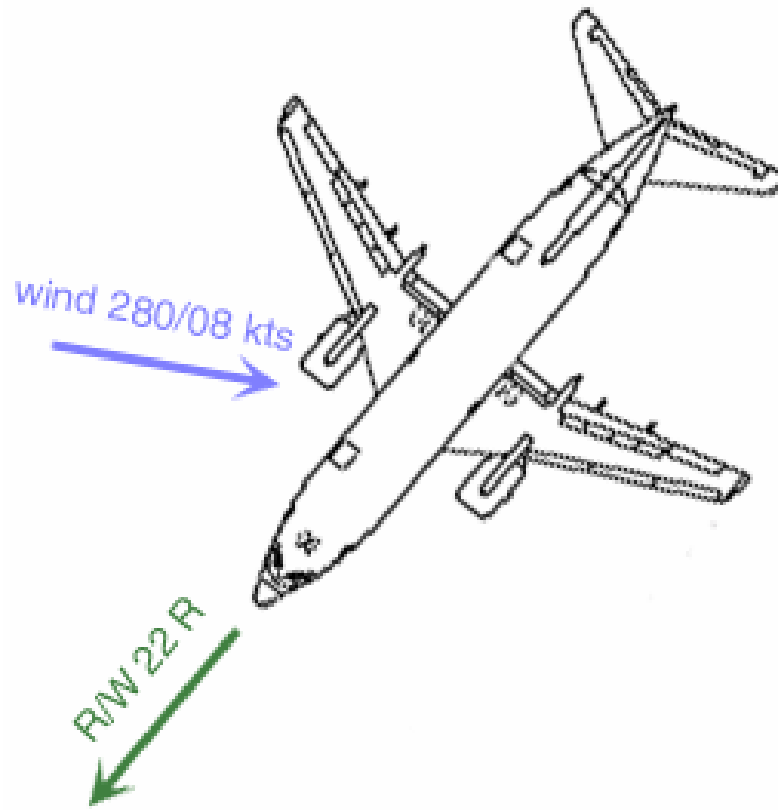
Figure 2.5.2.2 Wind direction during T.O

- The wind condition was 280/08 at Take Off. The aircraft was taking off from runway 22R, with a relative wind direction of about 60 degrees. The cross wind component was about 6.9 kts blowing from the right side of the airplane.

- Aileron movement direction during Takeoff is consistent with the wind condition existing during the Takeoff.
- Aileron bias change could be related to change in airplane speed.

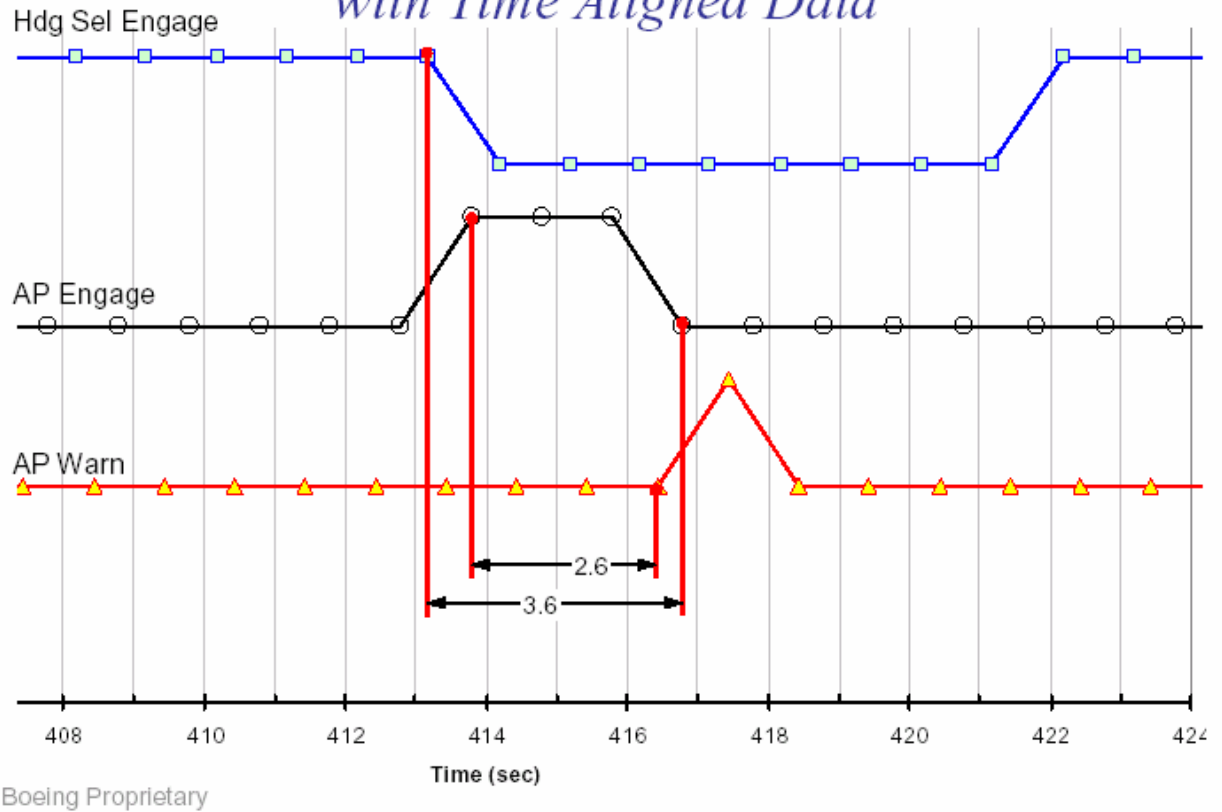
Figure 2.5.7.3 Autopilot Engage Attempt with Time Aligned Data

The investigation could not determine a higher possibility to any of the above findings based on the given data. However, with reference to the CVR/ FDR correlation, this event could have initiated crew distraction.

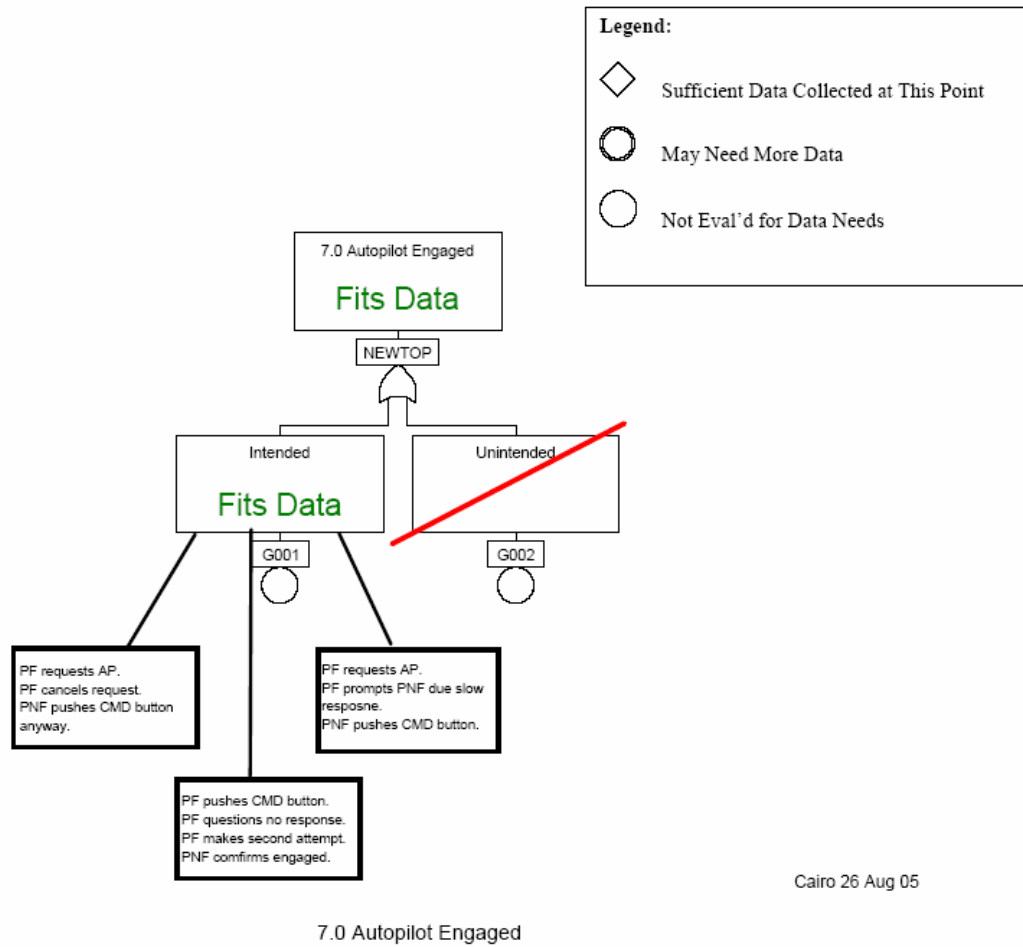
Figure 2.5.7.5 Autopilot Engage fault Tree Analysis

After ruling out the conditions which are unlikely to occur as mentioned above, the possible condition that could have led to this event is that the autopilot was Engaged with FD Roll Bar > 7 Degrees (with time lag)

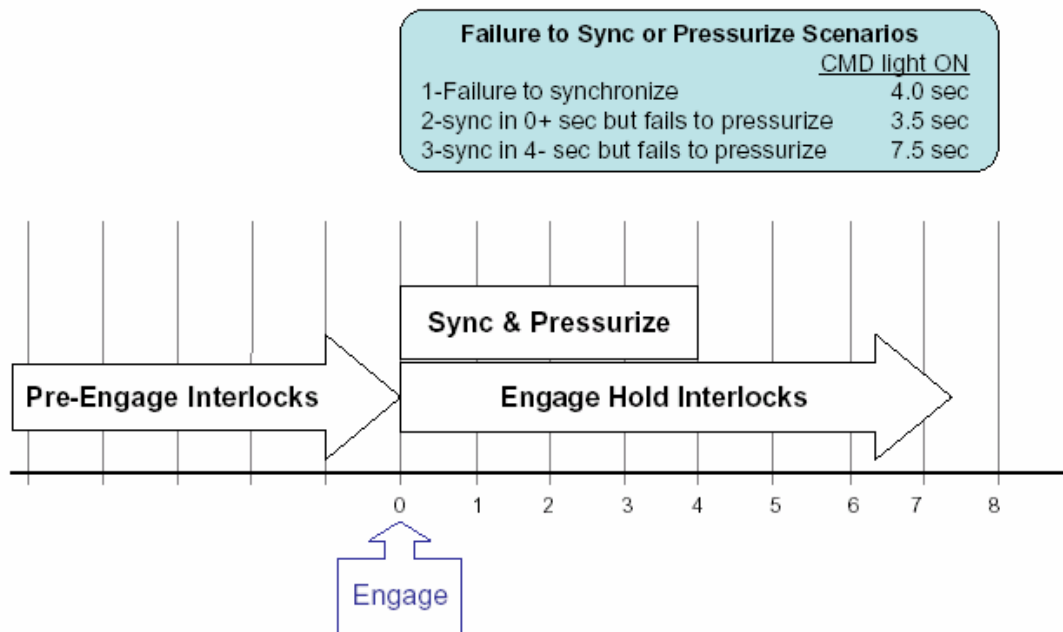
Figure 2.5.10.2 Autopilot Engage Logic

Any of the following three conditions cause autopilot disengagement:

- A. The engage synchronization (actuator to surface) & pressurization failed to complete  
(Failure to synchronize 4.0 sec/ sync in 0+ sec but fails to pressurize 3.5 sec/  
sync in 4- sec but fails to pressurize 7.5 sec)

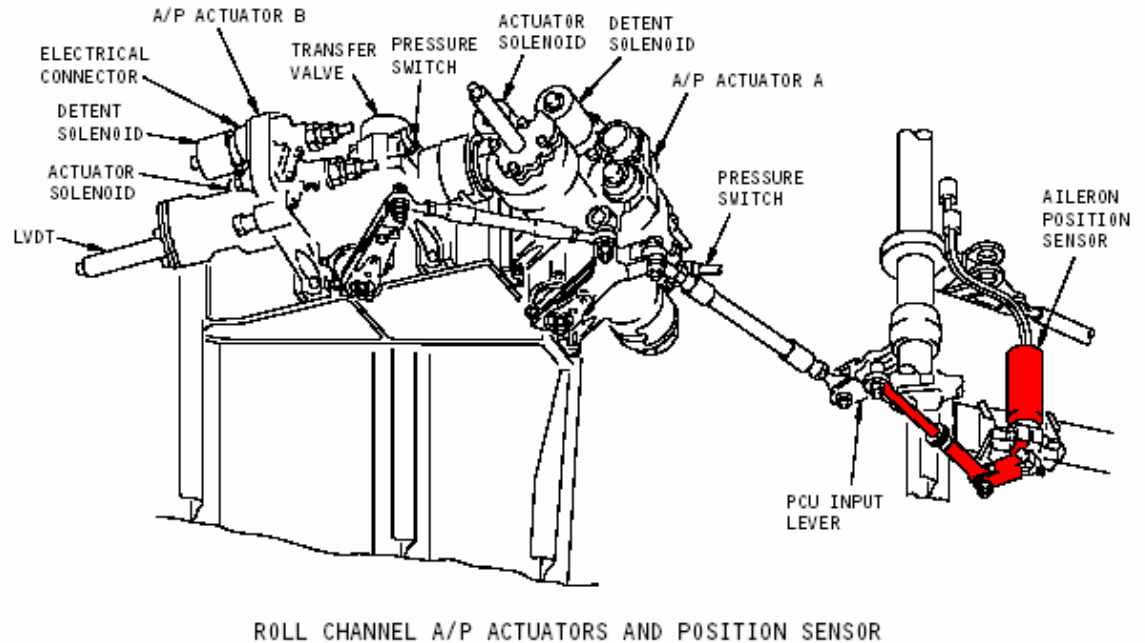
Fig 2.5.10.3 Roll channel autopilot actuator and position sensor<sup>2</sup>

The first step of autopilot engagement is synchronization. The arm solenoid opens and the FCC issues transfer valve commands to move the autopilot pistons to match the current location of the output crank. However, since the detent solenoid is closed, the detent pistons are free to move and the autopilot piston motion does not affect the output crank to the lateral system.

The FDR receives the ailerons position data; however, the autopilot actuator piston position is not recorded.

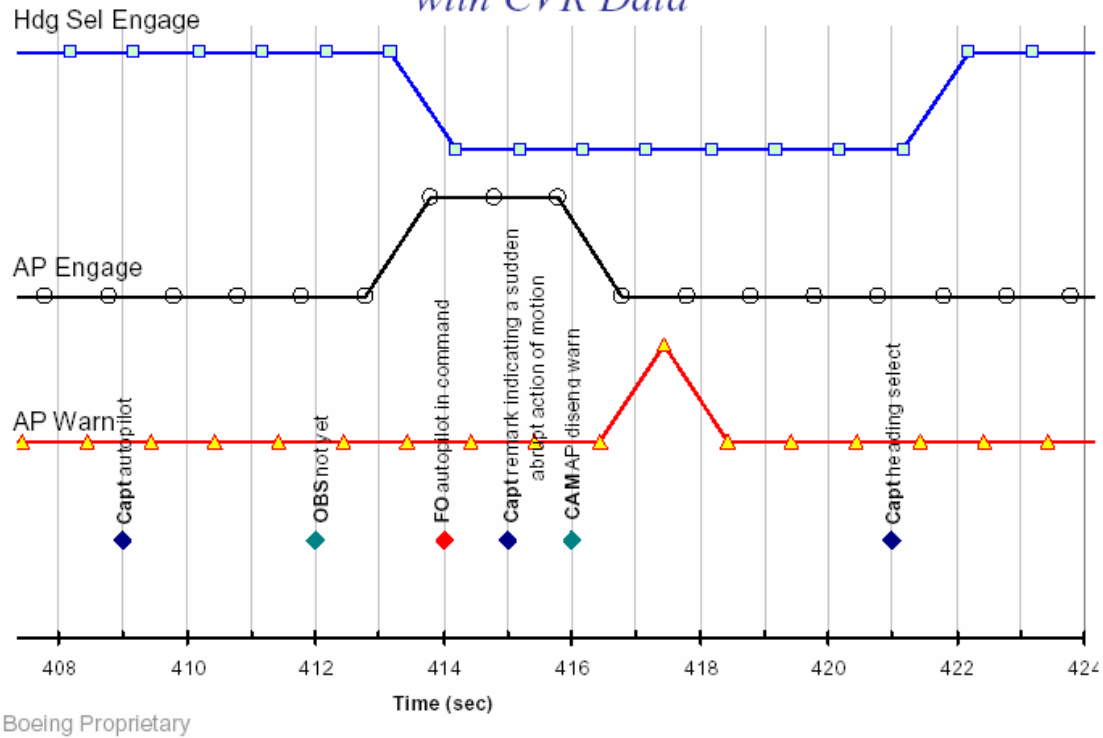
## Autopilot Engage Attempt with CVR Data

The CVR statement "Not yet" is not attributed to the observer but to the Captain.

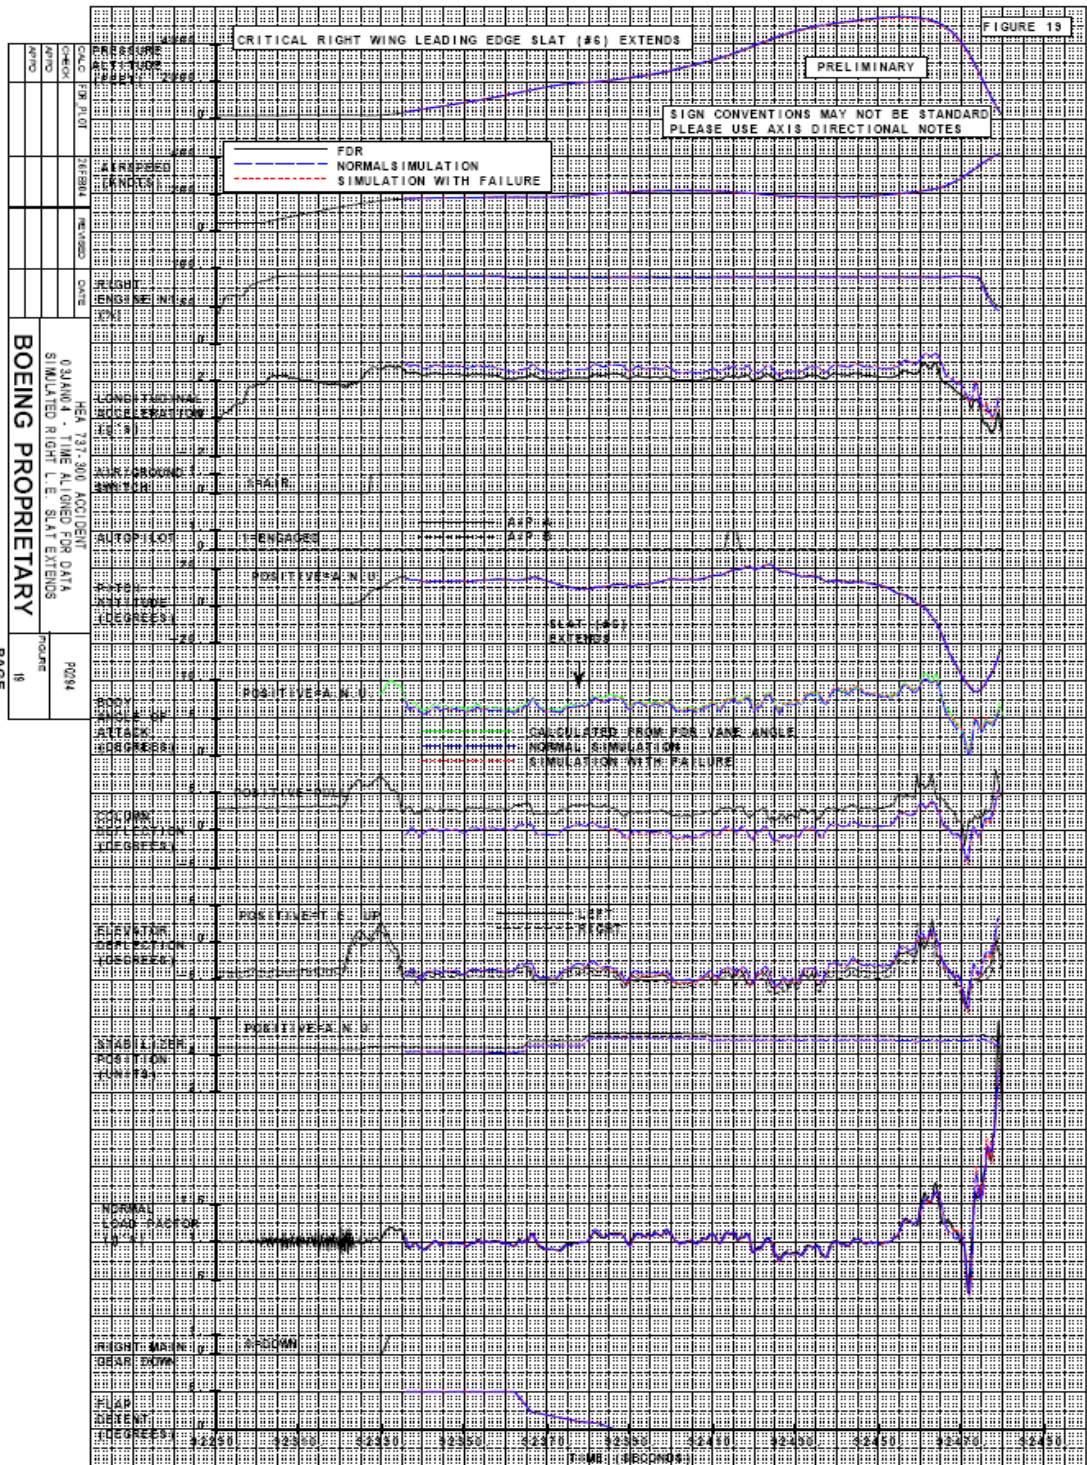
Figure 2.5.13.2a Critical right L.E. Failure- Slat #6 extends (longitudinal)

Based on the performance evaluation, M-Cab results  
(Simulation match to FDR) this condition could be ruled out.  
(See following M-Cab results figures)

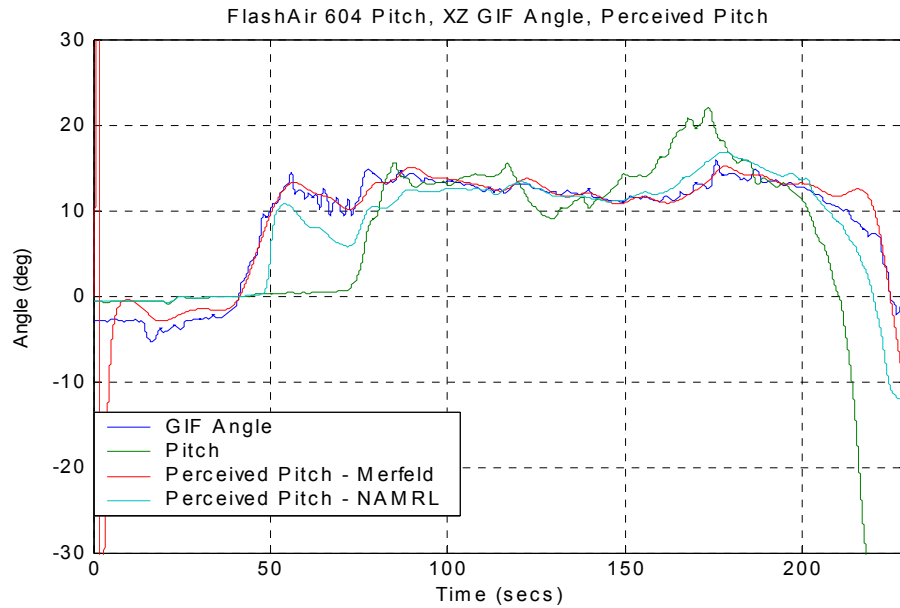
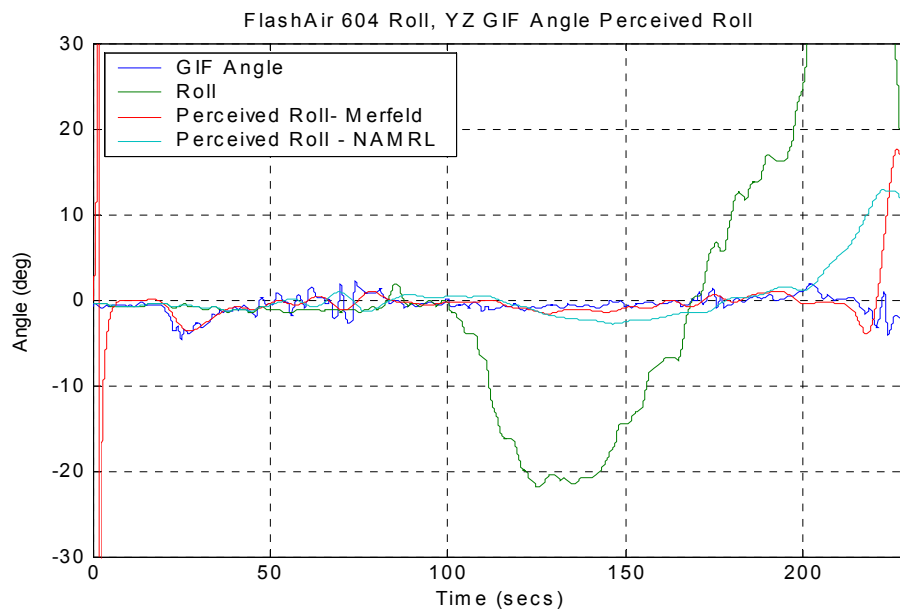
1) There is a difference between the resultant gravito-inertial vector angle and the aircraft attitude in pitch and roll. Due to this difference, both perceptual models estimate pitch and roll misperception. not been validated by additional analysis using the Merfeld or other perceptual models .

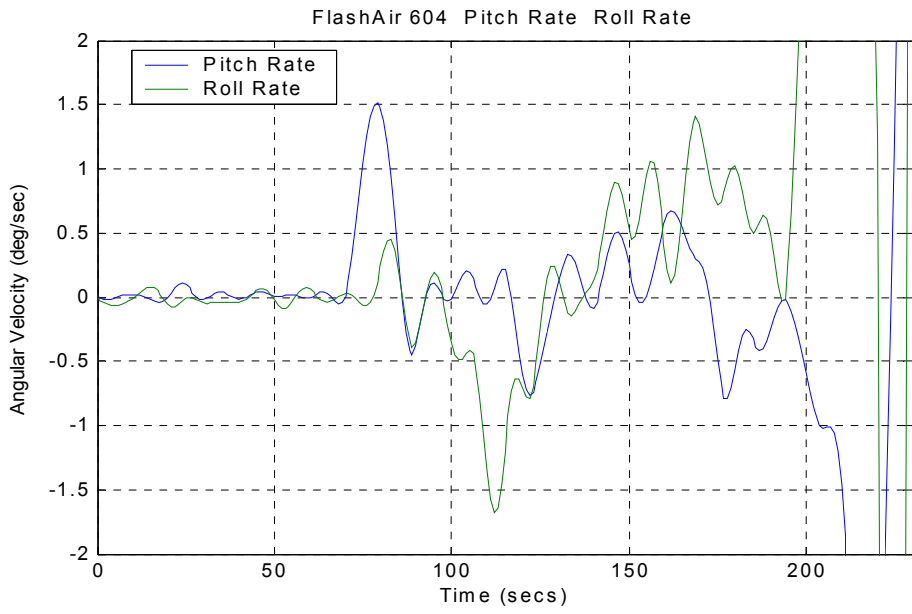
2) The angular rates are in the range of 1.0– 2.0 deg/sec. This magnitude is within the range of thresholds for detection of angular motion published in the literature. This indicates possible undetected attitude changes – especially the roll because of the resultant YZ GIF angle remains at zero. In addition to the Merfeld model, NAMRL researchers will attempt to investigate this possible sub-threshold roll input more thoroughly using additional models published in the literature.

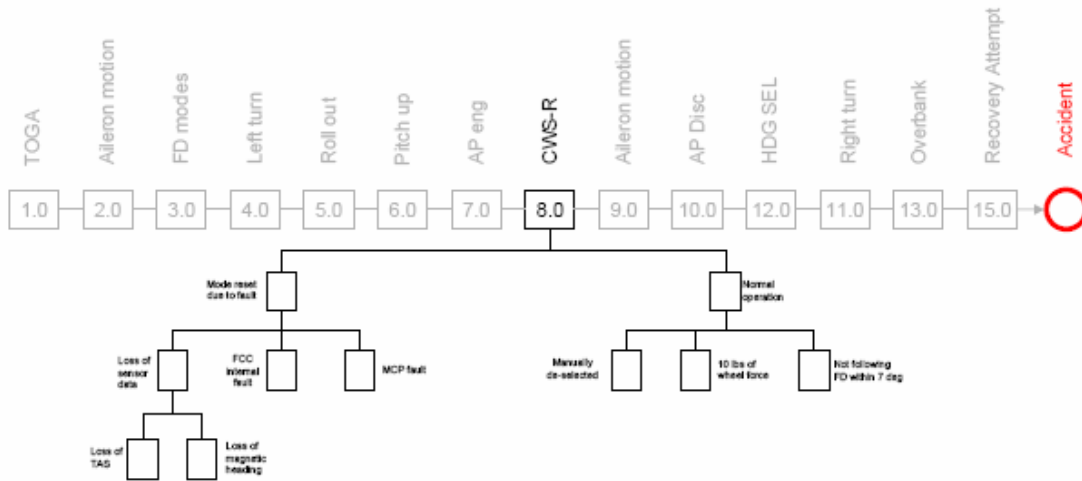
## Step 2 – Develop candidate scenarios for each event

Example shows scenario tree structure for event 8.0

Similar trees were developed for each event
